Detailed Unexploded Ordnance
Risk Assessment

In Respect Of:
Hamble Airfield - Update

For:
CEMEX

Report Reference:
RA 9091

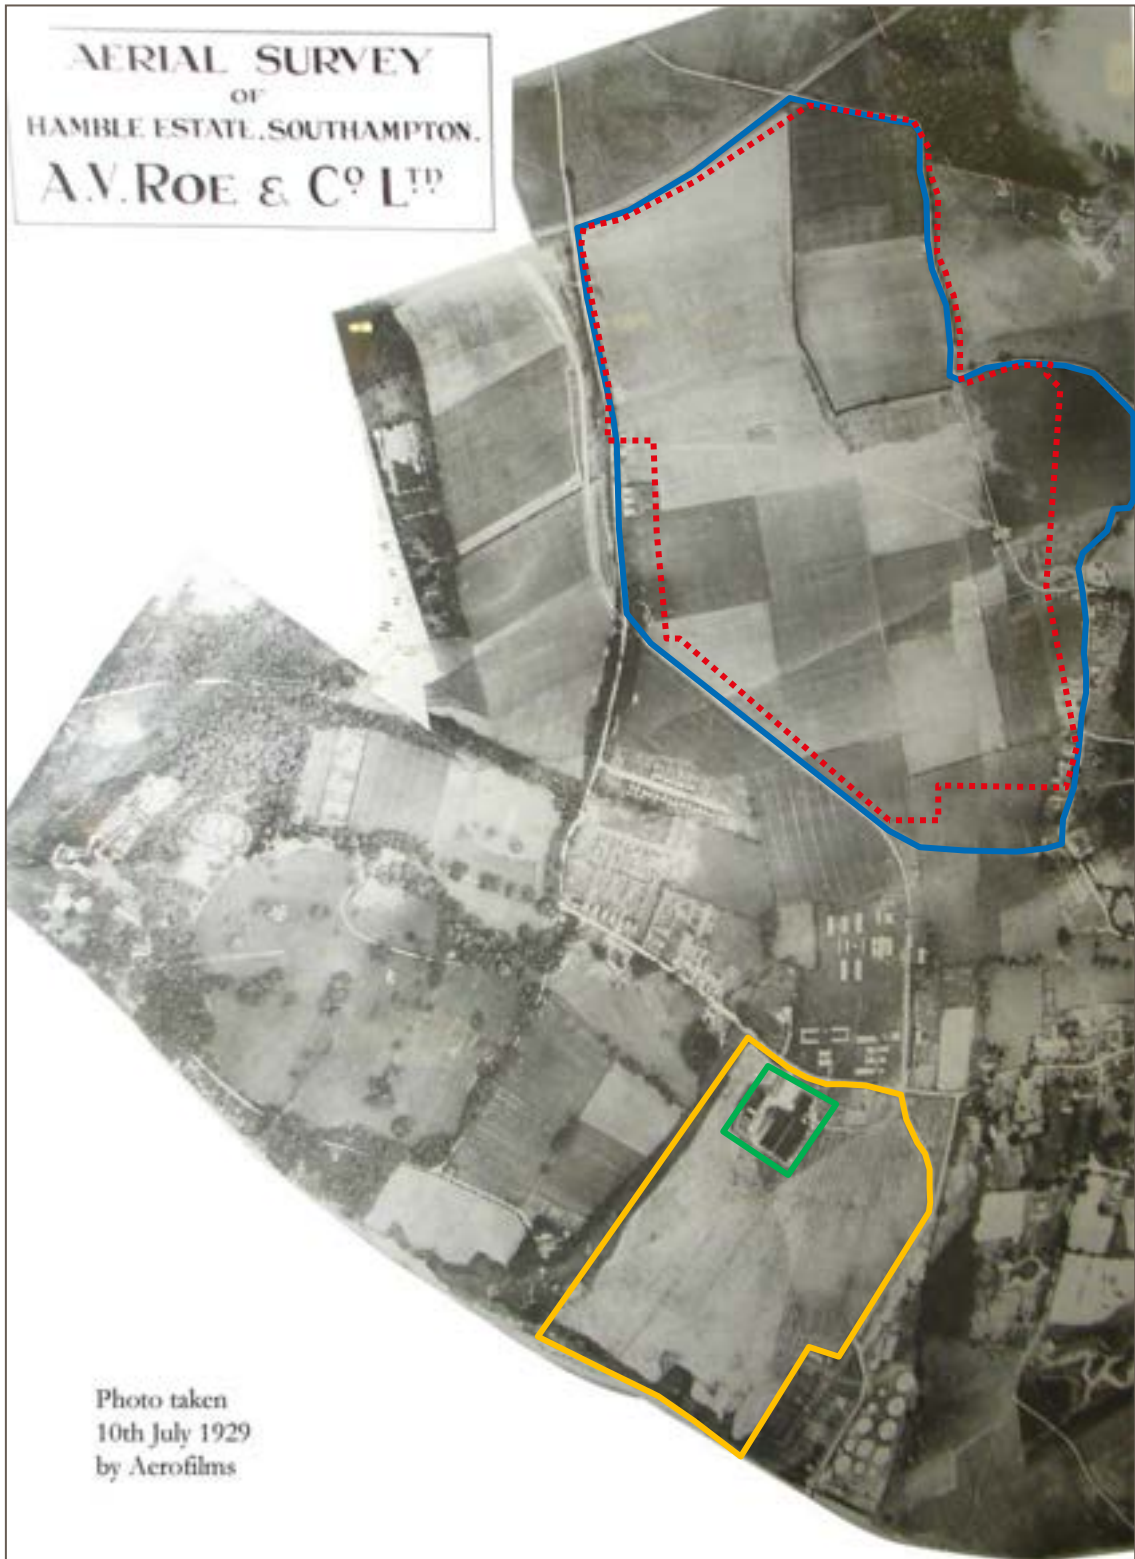
AERIAL SURVEY
OF
HAMBLE ESTATE, SOUTHAMPTON.
A.V. ROE & C^o L^{td}

Photo taken
10th July 1929
by Aerofilms

- Approximate site boundary
- Approximate area of South Airfield
- Armstrong and Whitworth Factory
- Approximate area of North Airfield

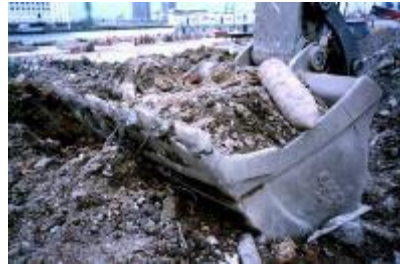
50kg bomb, London Docklands

The smallest and most common bomb. Nearly 70% of bombs dropped on the UK were 50kg.

Minus tail section

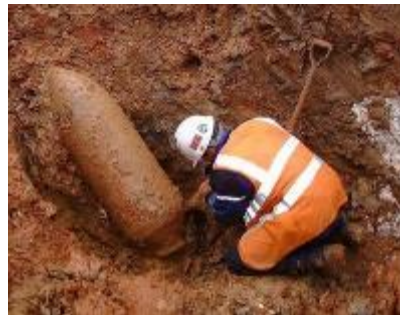
250kg bomb, Hawkinge

Bomb weight: 245-256kg (540-564lb)
 Explosive weight: 125-130kg (276-287lb)
 Fuze type: Electrical impact/mechanical time delay fuze.
 Bomb dimensions: 1640 x 512mm (64.57 x 20.16in)
 Body diameter: 368mm (14.5in)
 Use: Against railway installations, embankments, flyovers, underpasses, large buildings and below-ground installations.

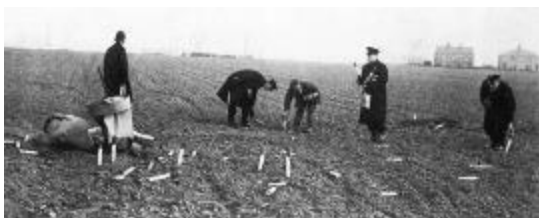
Bomb weight: 1.0 and 1.3kg (2.2 and 2.87lb)
 Filling: 680gm (1.3lb) Thermite
 Fuze type: Impact fuze
 Bomb dimensions: 350 x 50mm (13.8 x 1.97in)
 Body diameter: 50mm (1.97in)
 Use: As incendiary - dropped in clusters against towns and industrial complexes

Remarks: Jettisoned from air-dropped containers, Magnesium alloy case. Sometimes fitted with high explosive charge

1. Scaffold pipe
2. Incendiary 1kg bomb
3. Incendiary bomb recently found on site in UK

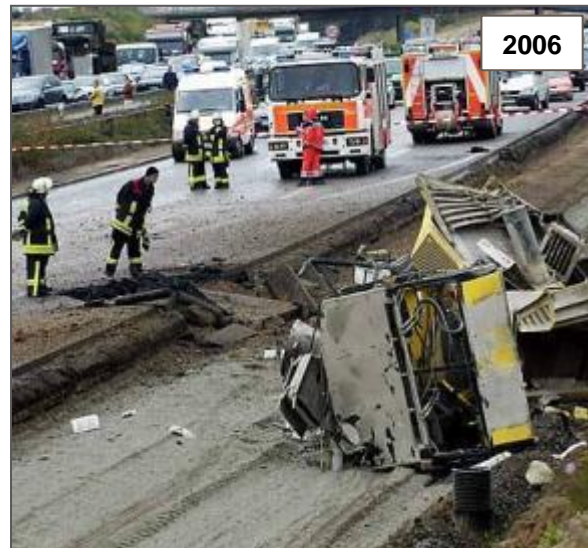
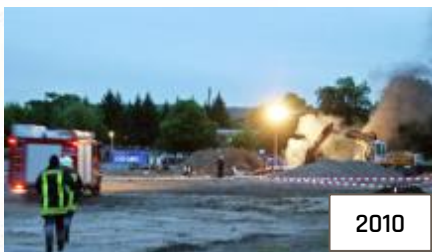
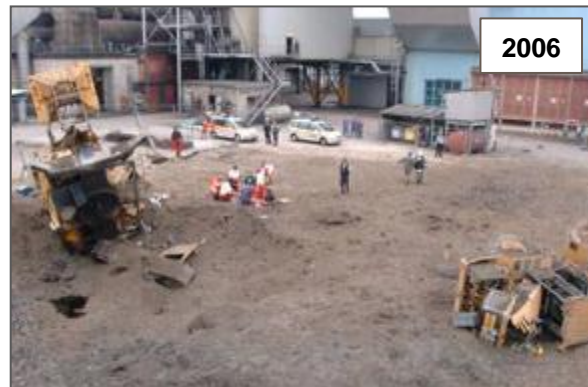
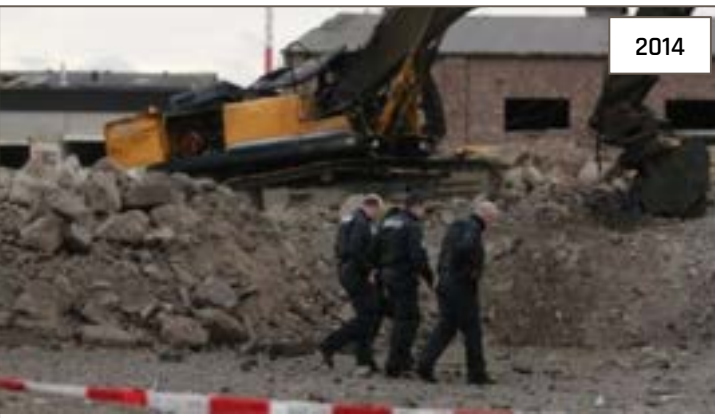
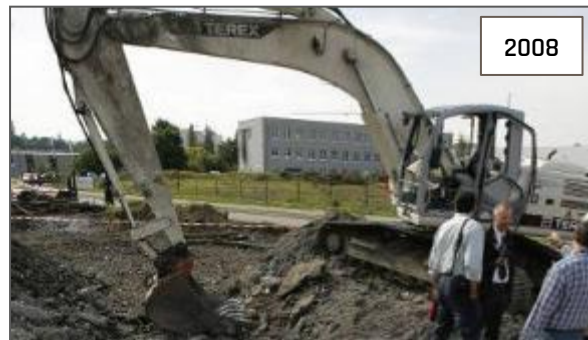
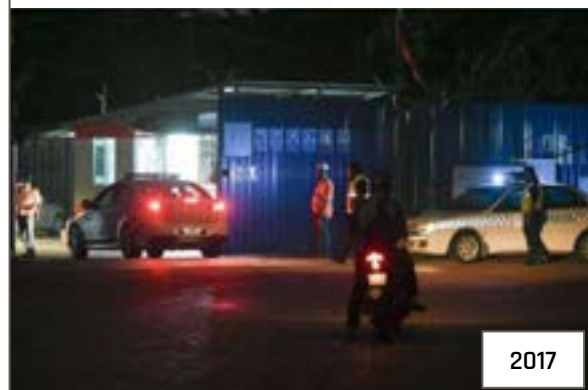
RESCUE workers search for survivors after a Second World War bomb exploded at a building site in Berlin, killing three people and injuring at least eight others.
A fire brigade spokesman said he feared the final death toll could be higher. One worker was still missing, believed to be trapped under a machine. "We've

Workers building a sports stadium had earlier unearthed the bomb in the town of Goettingen.

It was not immediately clear why the bomb, reportedly weighing 500kg (1,100lb), had detonated.

A World War Two bomb has exploded at a construction site near a west German town, killing a man and injuring eight others, police say.

The explosion occurred after a digger accidentally struck the device during excavation work in Euskirchen in the state of North Rhine-Westphalia.

1 dead, 2 critical after explosion at Malaysia MRT construction site caused by WWII bomb

Top Left: WWII bomb killed 3 and injured 8 in Berlin - 1994.
Middle Left: WWII bomb killed 3 in Goettingen, Germany - 2010.
Bottom Left: Excavator operator killed by WWII bomb in Euskirchen, Germany - 2014.
Top Right: A highway construction worker in Germany accidentally struck a WWII bomb, killing himself and wrecking several passing cars - 2006.
Middle Right (Top) : Destroyed piling rig and dump truck after detonation of WWII UXB in Austria - 2006.
Middle Right (Bottom): WWII bomb injures 17 at construction site in Hattingen, Germany - 2008.
Bottom Right: A buried WWII-era bomb exploded during construction works in Bandar Malaysia, Kuala Lumpur - 2017.

Annex G-2 details UXB incidents where intrusive works have caused UXBs to detonate, resulting in death or injury and damage to plant.

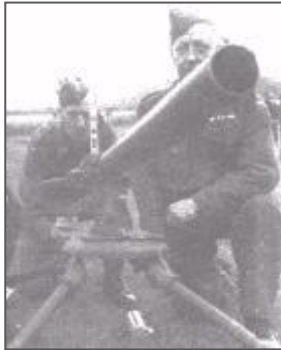
Self Igniting Phosphorous (SIP) Grenades

Filling: White Phosphorous and Benzene
 Remarks: The grenade comprised a glass bottle with a total volume of approximately one pint. It was filled with White Phosphorous, benzene, a piece of rubber and water. Over time the rubber dissolved to create a sticky fluid which would self ignite when the bottle broke. Fired by hand or Northover Projector. Sometimes called the "A & W" (Albright & Wilson) grenade.

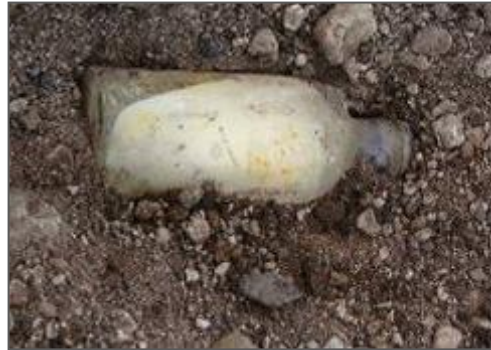
No 74 Grenade (Sticky Bomb)

Remarks: Designed as an anti-tank grenade and used by the Home Guard. The grenade consisted of a glass ball on the end of a Bakelite (plastic) handle. Inside the glass ball was an explosive filling whilst on the outside was a very sticky adhesive covering. Until used, this adhesive covering was encased in a metal outer casing.

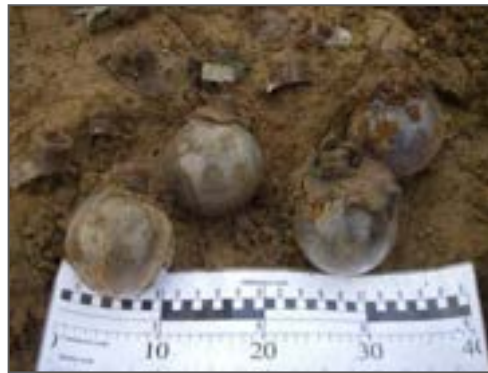
Flame Fougasse Bomb

Remarks: A Flame Fougasse was a weapon in which the projectile was a flammable liquid, typically a mixture of petrol and oil. It was usually constructed from a 40-gallon drum dug into the roadside and camouflaged. Ammonal provided the propellant charge which, when triggered, caused the weapon to shoot a flame 3m (10ft) wide and 27m (30 yards) long. Initially a mixture of 40% petrol and 60% gas oil was used, this was later replaced by an adhesive gel of tar, lime and petrol known as 5B.

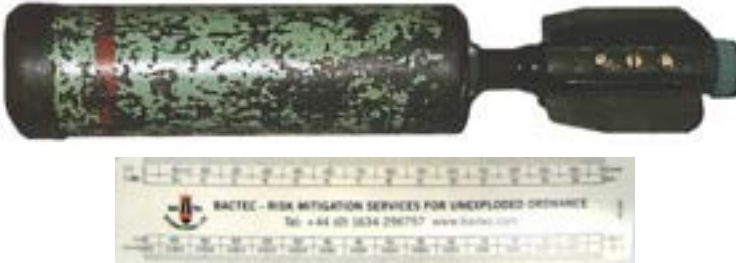
Bomb Weight: 1.02kg (2.25lb)
 Type: High Explosive
 Dimensions: 51 x 290mm (2in x 11.4in)
 Filling: 200g RDX/TNT
 Maximum Range: 457m (500yds)

Remarks: Fitted with an impact fuze which detonates the fuze booster charge (exploder) and, in turn, the high explosive charge. The main charge shatters the mortar bomb body, producing near optimum fragmentation and blast effect at the target.

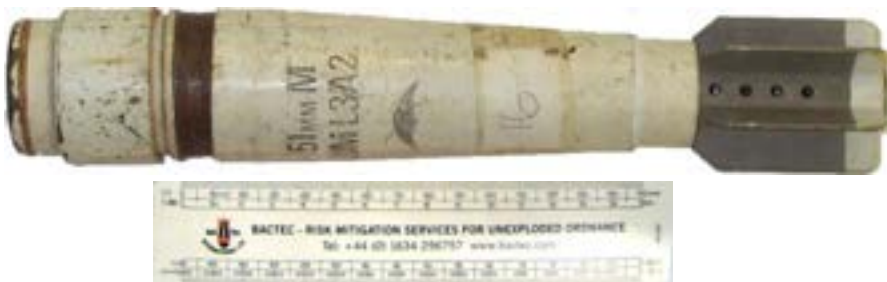
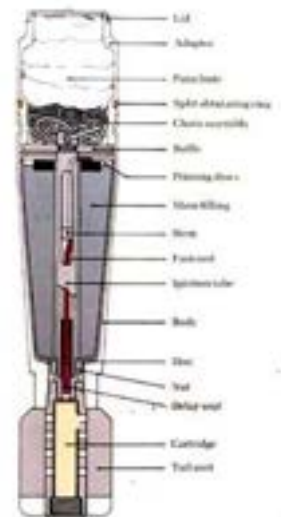
Typical 2 inch Illuminating Mortar

Type: Illum.
 Dimensions: 51 x 290mm
 Filling: Various

Remarks: The expulsion charge ignites and ejects the candle assembly. A spring ejects the parachute from the tail cone. The parachute opens, slowing the descent of the burning candle which illuminates the target.

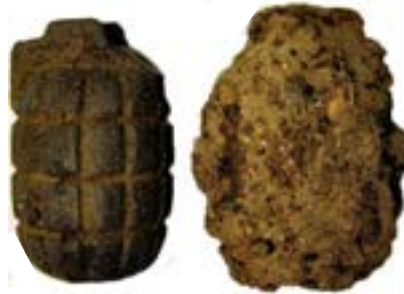
Grenade, .303 inch rifle, No. 36M, Mark I.

Weight: 0.7kg filled (1lb 6oz)
 Type: Hand or discharger, fragmentation
 Dimensions: 95 x 61mm (3.7 x 2.4in)
 Filling: Alumatol, Amatol 2 or TNT
 Remarks: 4 second hand-throwing fuse with approximate 30m range. First introduced May 1918.

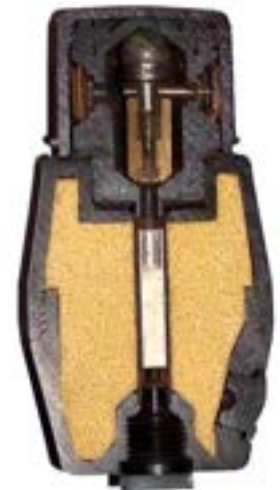
No. 69 Grenade

Weight: 0.38kg filled (0.8lb)
 Type: Percussion/Blast
 Date Introduced: December 1940
 Remarks: Black Bakelite body. Blast rather than fragmentation type. After unscrewing the safety cap, a tape is held when throwing the grenade releasing the safety bolt in the throwing motion. Detection is problematic due to its very low metal content.

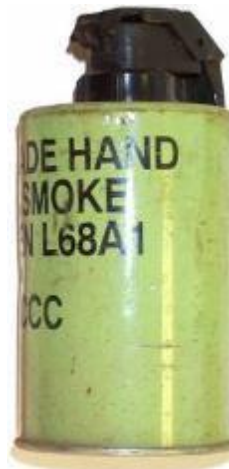
Typical Smoke Grenade

Dimensions: Approx. 65 x 115mm (2.5 x 4.5in)
 Type: Smoke
 Date Introduced: Current MoD issue
 Remarks: Smoke grenades are used as ground-to-ground or ground-to-air signalling devices, target or landing zone marking devices, and screening devices for unit movement.

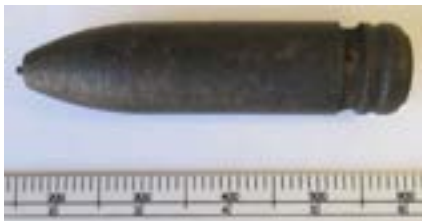
20mm Hispano HEI Ammunition

Type: Live cannon round
 Markings: Upper half of projectile painted 'buff' colour, lower half is red.
 Cartridge Weight: 256 grams
 Dimensions: Total cartridge / projectile length - 182mm
 Fuzed: Contact fuze - No.253, No.254 or No.917
 Filling: 108 grains of contact explosive + 68 grains of SR.379 incendiary composition.
 Threat: Explosives within unspent cartridge as well as the projectile.
 Deployment: Royal Navy, RAF and British Army Light Anti- Aircraft guns. Also RAF aircraft cannons.
 Remarks: Cartridges are belted or supplied loose in cartons.

COLOUR IDENTIFICATION		
BRITISH		
NATURE OF SHELL	HE-FILLING	COLOR
H.E. TRACER	TNT	Blue
H.E.	TNT	Orange
PROJ. PRACTICE		Purple
PROJ. TRACER		Green
H.E. INCENDIARY	TNT	Red
H.E. INCENDIARY TRACER	TNT	Green

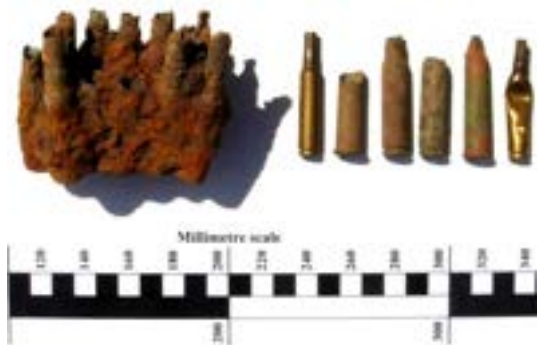
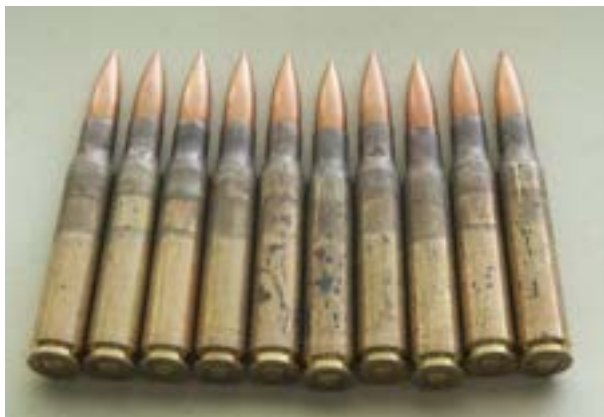
.303" Ammunition

Type: Rifle / machine gun round
 Markings: Regular round - none. Tracer round - red Primer
 Bullet Weight: 150 - 180 grams
 Dimensions: Total cartridge /projectile length - 78mm
 Filling: Regular round - none. Tracer round - small incendiary fill
 Threat: Explosive cordite within unspent cartridge
 Deployment: Royal Navy, RAF and British Army Light Anti- Aircraft guns, machine guns and rifles. Standard British and Commonwealth military cartridge from 1889 until the 1950s.
 Remarks: Cartridges are belted or supplied loose in cartons.

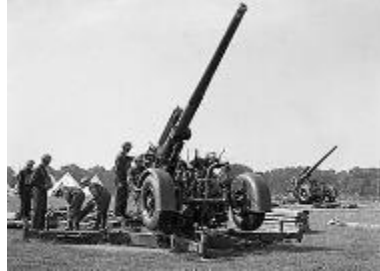
Hyde Park 1939 3.7 inch QF gun on a mobile mounting

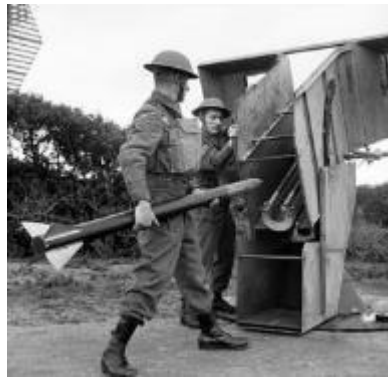
Home Guard soldiers load an anti-aircraft rocket at a 'Z' Battery

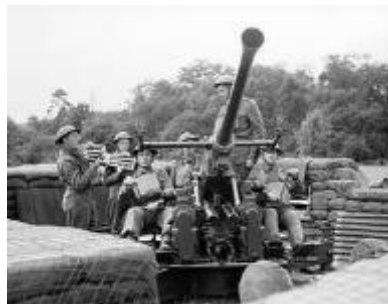
40mm Bofors gun and crew at Stanmore in Middlesex, 28 June 1940.
