PROPOSED MINERAL WORKINGS: Landscape and Visual Impact

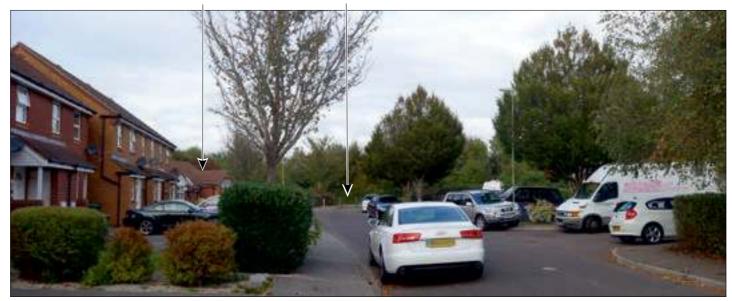
VIEWPOINT: 5 **LOCATION:** Tutor Close, Hamble; Ground Level

Screen mound and Operational Phase 3 set 100m beyond mature treeline

Footpath along former railway 67 Tutor Close

Mature planting screens footpath route and 1990's housing estate

View north-eastwards, 90m from application area boundary and 150m minimum from extraction area; boundary vegetation and housing development provides a very good degree of screening. Glimpsed winter view of development will comprise associated soil screen mounds set 70m into the site, 130m minimum from viewpoint. Views from properties will be oblique and not main focus of view.

Level plateau topography - Semi-enclosed by woodlands and hedgerows. at edge of Hamble village fringe - 1990's

brick-built housing over part of former airfield.

Magnitude of Impact: **NEGLIGIBLE** Significance of View without Mitigation: **MINOR ADVERSE**

Autumn view: Winter views will be more exposed

Grassed soil storage mounds 4.0m high will be located to the site boundary, inside the line of existing woodland planting;

Significance of View with Mitigation: NEGLIGIBLE
