Hamble Quarry: infiltration testing

Factual report

331201108R6, October 2022

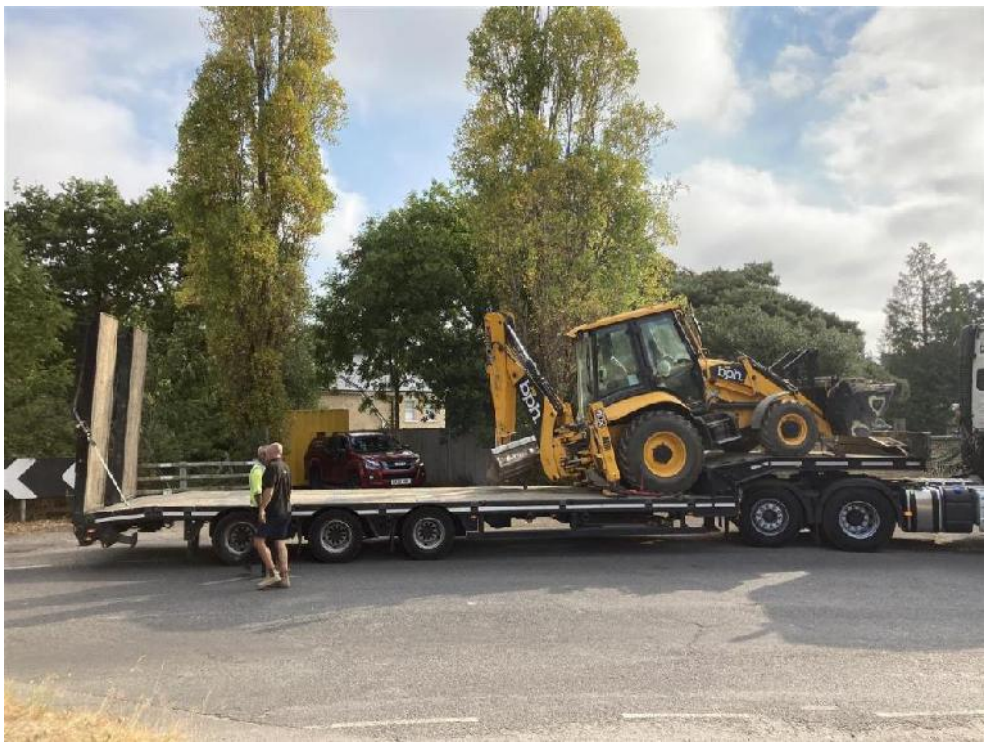
Client:	CEMEX UK Operations Ltd	Project:	331201108
Site Name:	Hamble Quarry - infiltration testing	Site Location:	Satchell Lane, Hamble-le-Rice, Southampton
Photograph ID: 1

Photo Location: Satchell Lane			
Direction:			
Survey Date: 15/08/2022			
Comments: Delivery of JCB 3CX			
Photograph ID: 2

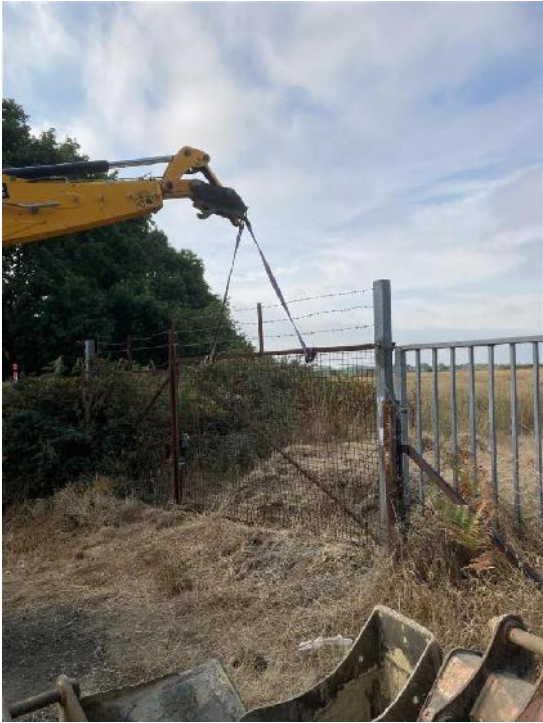
Photo Location: Entrance to Site			
Direction:			
Survey Date: 15/08/2022			
Comments: Removal of the gate to access the Site, locked with secure topsoil bund

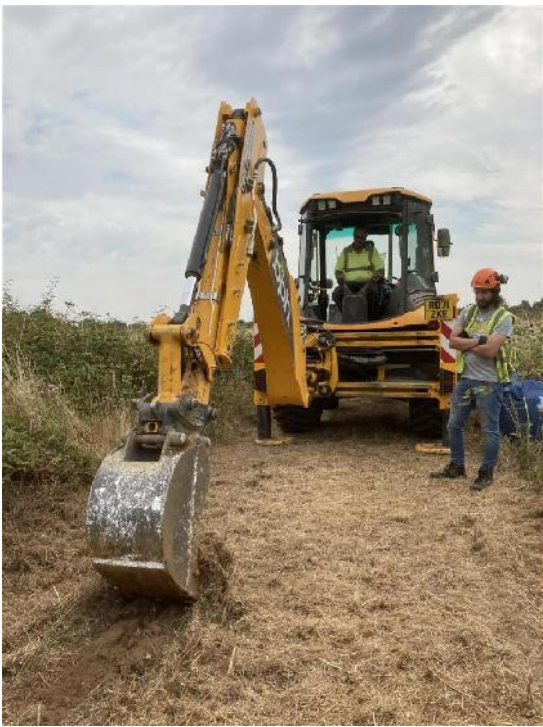
Photograph ID: 8

Photo Location: IT6_3	
Direction:	
Survey Date: 15/08/2022	
Comments: Stripping of topsoil being supervised by an Ecologist

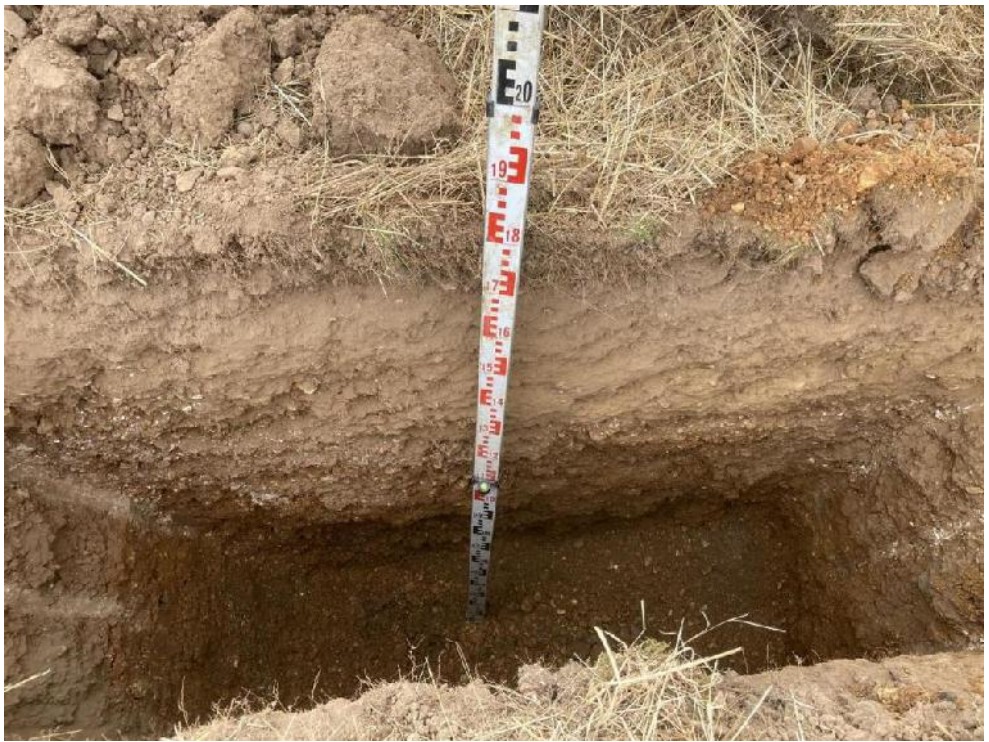
Photograph ID: 18

Photo Location: IT5_1	
Direction:	
Survey Date: 18/08/2022	
Comments: Trial pit depth 1.8 m bgl

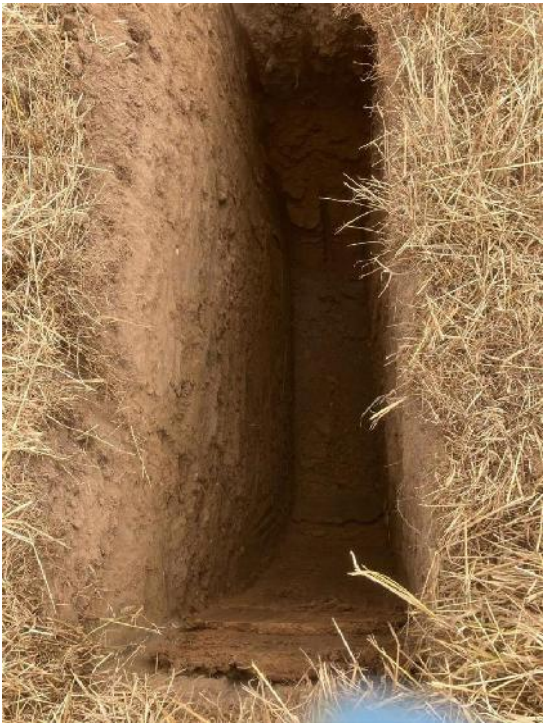
Photo Location: IT4_2			
Direction:			
Survey Date: 18/08/2022			
Comments: Trial pit			
Photograph ID: 20

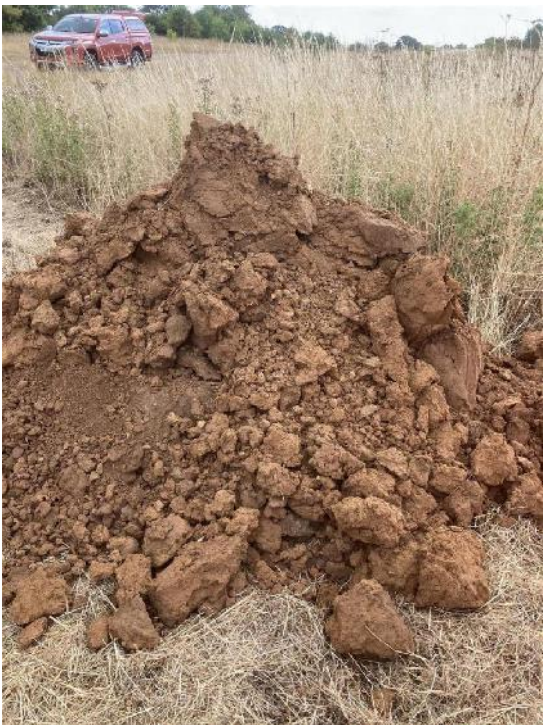
Photo Location: IT4_2			
Direction:			
Survey Date: 18/08/2022			
Comments: Arisings: subsoil (CLAY)

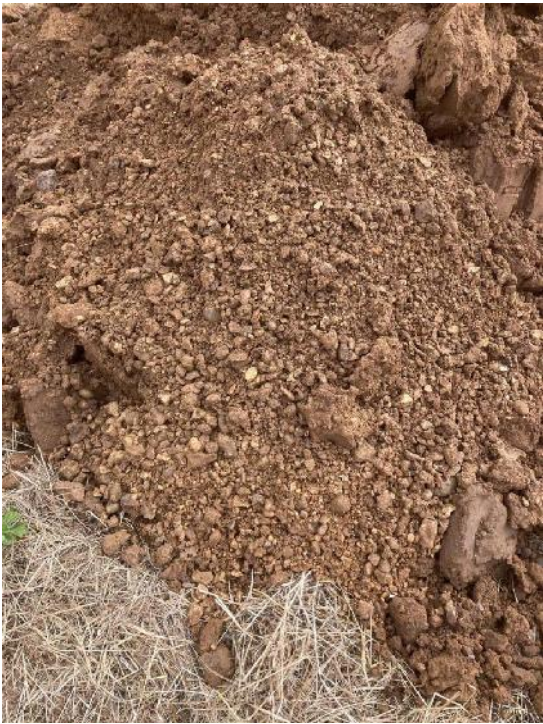
Photo Location: IT4_2			
Direction:			
Survey Date: 18/08/2022			
Comments: Arising: RTD encountered at 2.5m bgl			
Photograph ID: 22

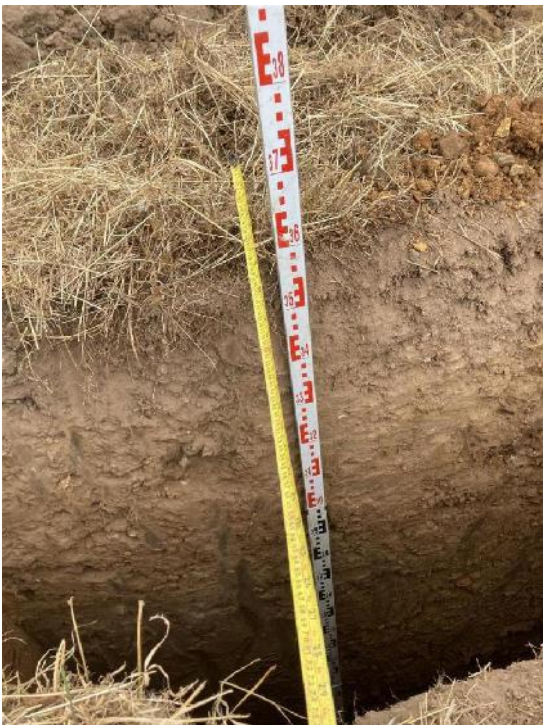
Photo Location: IT4_2			
Direction:			
Survey Date: 18/08/2022			
Comments: Trial pit depth 3.6 m bgl

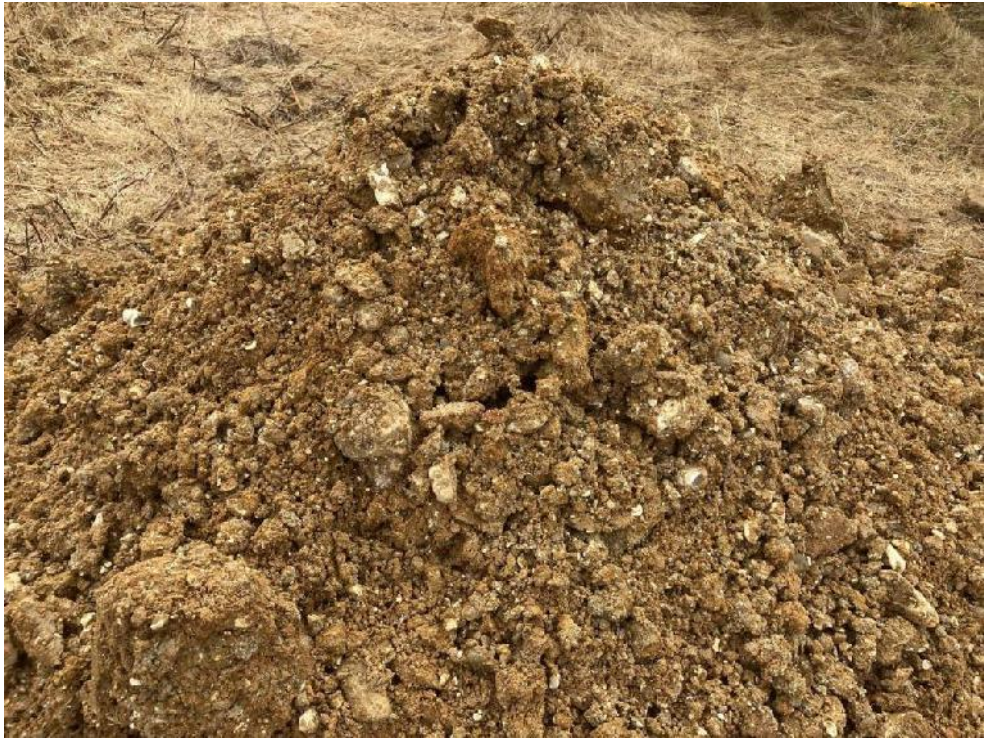
Photograph ID: 23

Photo Location: IT1_1	
Direction:	
Survey Date: 19/08/2022	
Comments: RTD from 0.4 to 1.0 m bgl

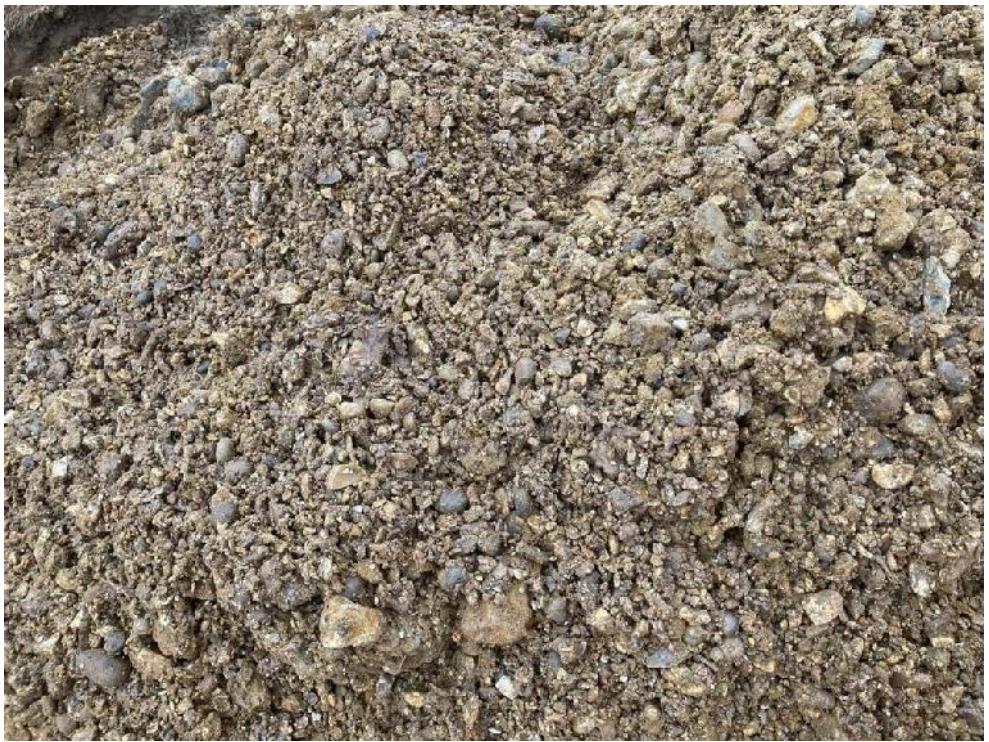
Photograph ID: 24

Photo Location: IT1_1	
Direction:	
Survey Date: 19/08/2022	
Comments: RTD from 1.0 to 1.7 m bgl

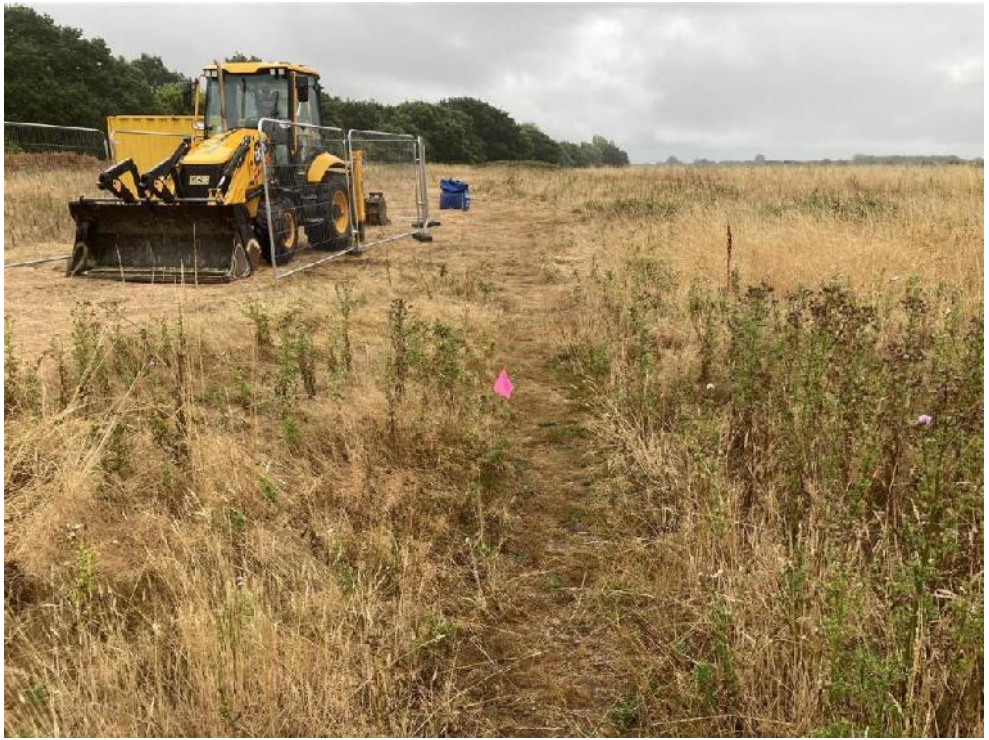
Client:	CEMEX UK Operations Ltd	Project:	331201108
Site Name:	Hamble Quarry - infiltration testing	Site Location:	Satchell Lane, Hamble-le-Rice, Southampton
Photograph ID: 25

Photo Location: IT1_2			
Direction:			
Survey Date: 19/08/2022			
Comments: Pinky flags placed on safe areas after GPR survey			
Photograph ID: 26

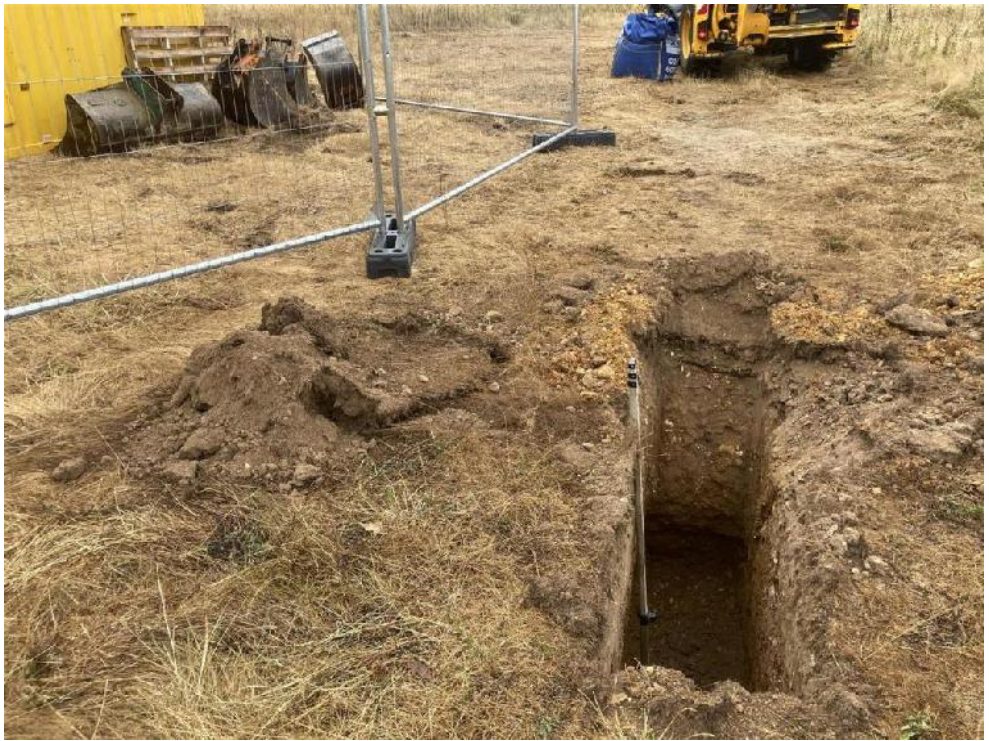
Photo Location: IT1_2			
Direction:			
Survey Date: 19/08/2022			
Comments: Measuring depth of the pit before undertaken infiltration testing

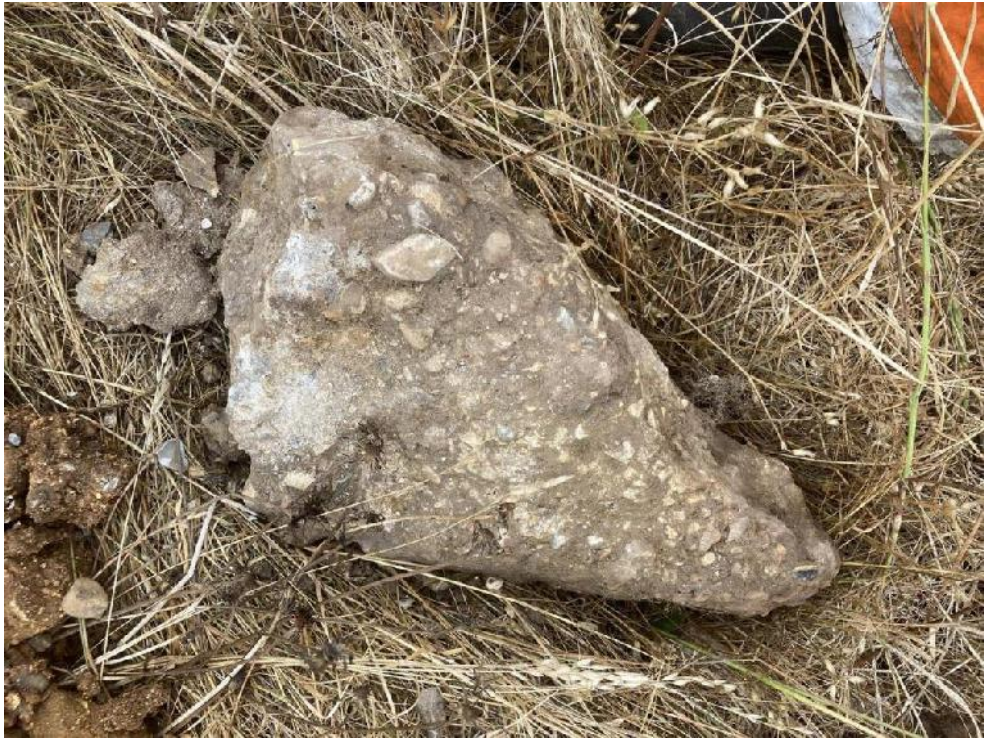
Photo Location: IT1_2			
Direction:			
Survey Date: 19/08/2022			
Comments: MG: Boulder of concrete			
Photograph ID: 28

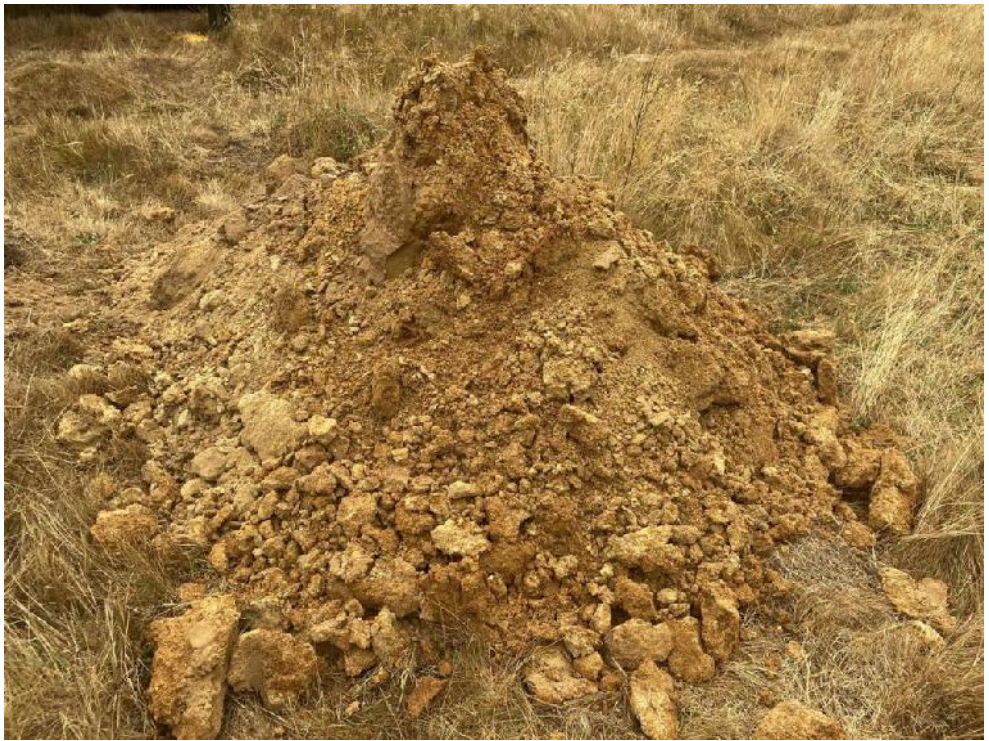
Photo Location: IT7_1			
Direction:			
Survey Date: 22/08/2022			
Comments: RTD: clayey SAND

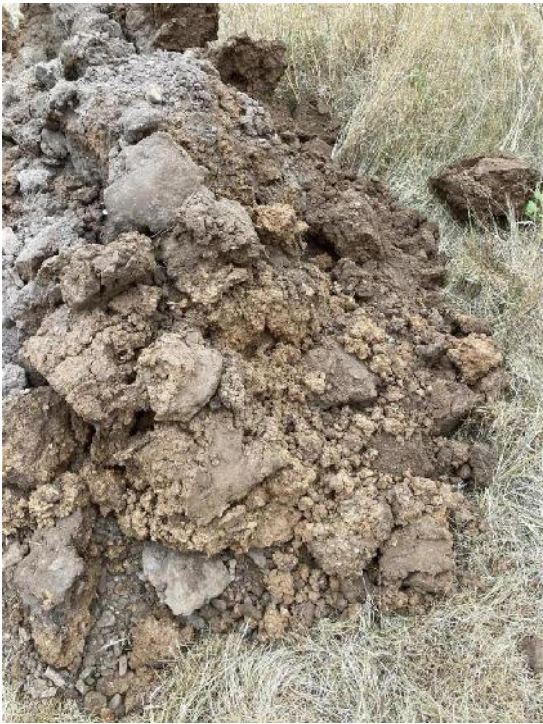
Photo Location: IT4_1			
Direction:			
Survey Date: 22/08/2022			
Comments: RTD: sandy gravelly CLAY			
Photograph ID: 30

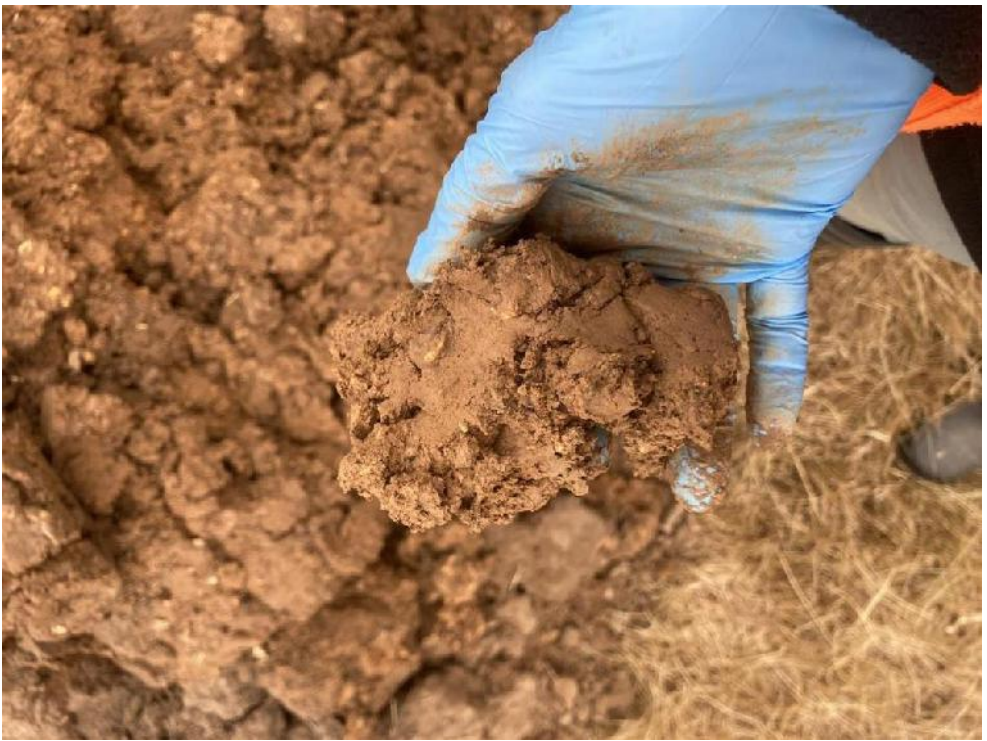
Photo Location: IT4_1			
Direction:			
Survey Date: 22/08/2022			
Comments: RTD: sandy gravelly CLAY

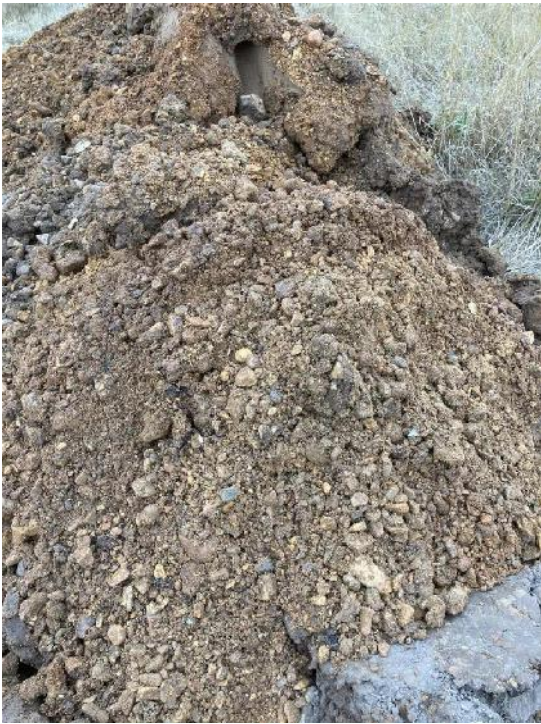
Photo Location: IT4_1			
Direction:			
Survey Date: 22/08/2022			
Comments: RTD: clayey sandy GRAVEL			
Photograph ID: 32

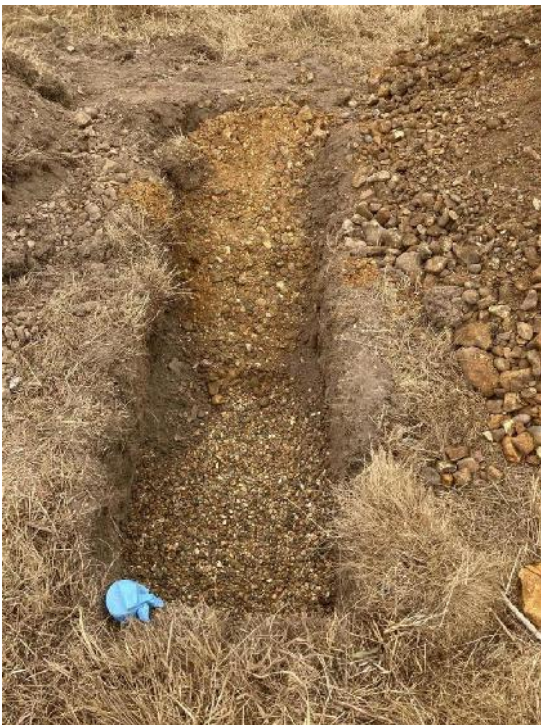
Photo Location: IT3_2			
Direction:			
Survey Date: 22/08/2022			
Comments: Pit had to be left open overnight - as recommended by the Ecologist the ramp was made to avoid any potential fauna loss

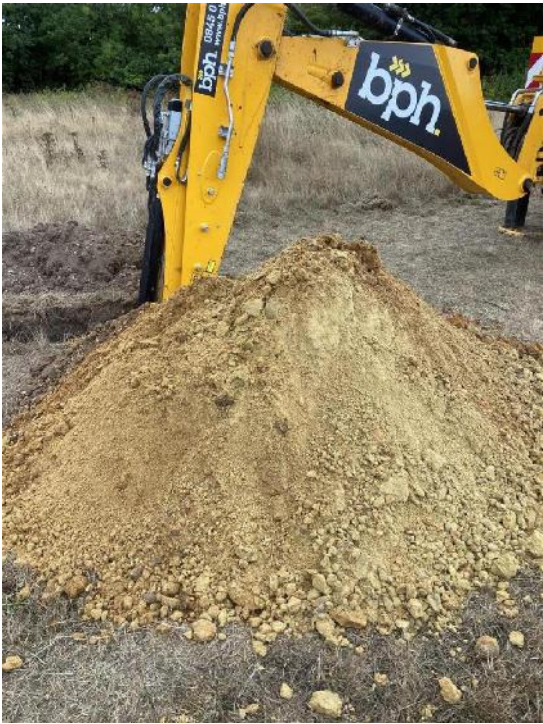
Photo Location: IT2_1			
Direction:			
Survey Date: 24/08/2022			
Comments: MARSH FARM FORMATION arisings			
Photograph ID: 34

The Marsh Farm Formation (SAND) was encountered at a very shallow depth in location IT2_1 (1.20 m bgl) and therefore the infiltration test was undertaken within this stratum. In an attempt to provide additional drainage data from this area, an extra location pit was excavated adjacent to it and named IT2_1B, however the geology encountered was similar to that from IT2_2, located southwards, with material comprising mainly CLAY and very clayey SAND. Given that the infiltration test undertaken in IT2_2 failed in reaching the 75% effective depth, it was decided not to undertake an additional infiltration test in IT2_1B.

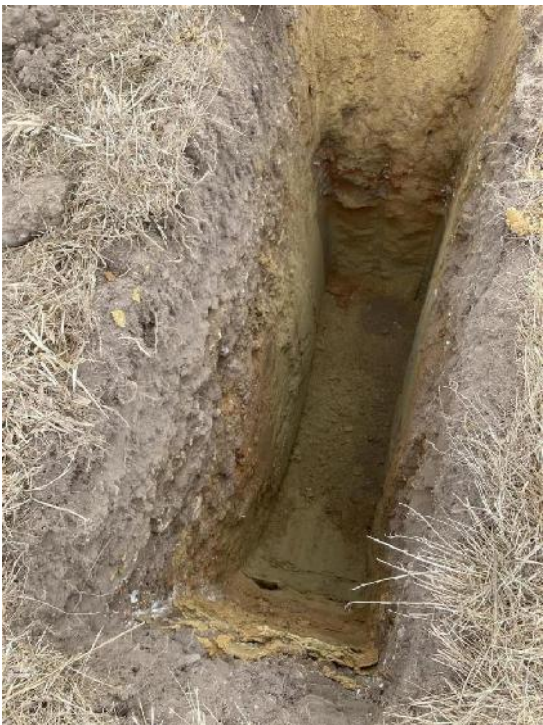
Photo Location: IT2_1			
Direction:			
Survey Date: 24/08/2022			
Comments: RTD and MARSH FARM FORMATION open pit

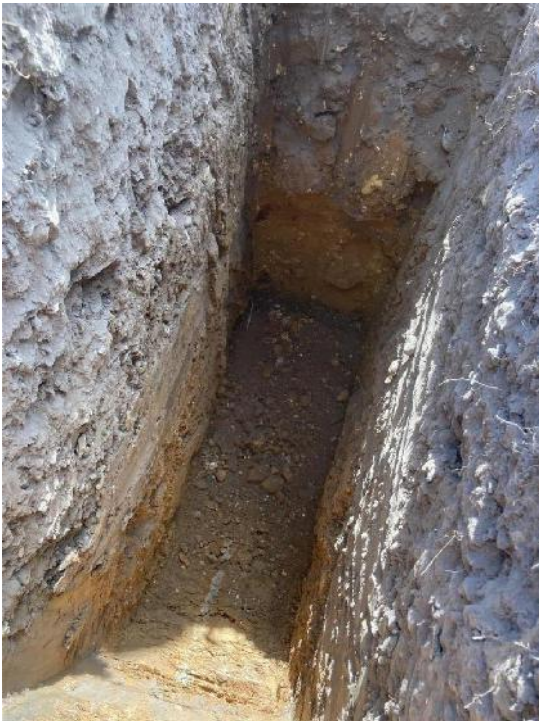
Photo Location: IT2_1B			
Direction:			
Survey Date: 24/08/2022			
Comments: Pit opened to check geology - no infiltration test undertaken

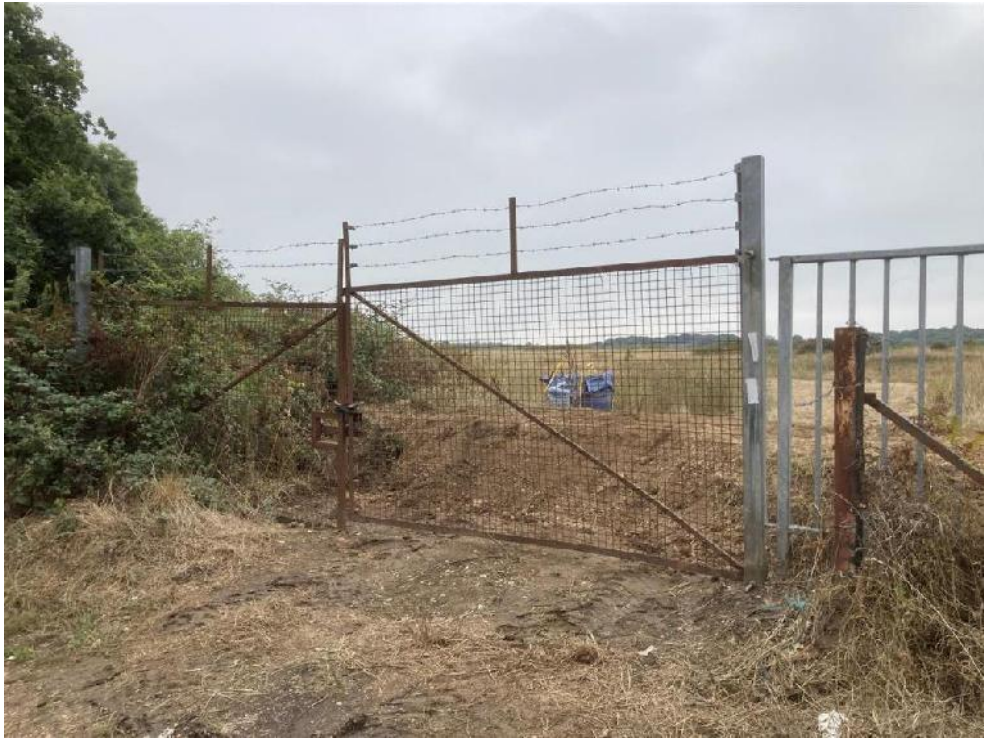
Client:	CEMEX UK Operations Ltd	Project:	331201108
Site Name:	Hamble Quarry - infiltration testing	Site Location:	Satchell Lane, Hamble-le-Rice, Southampton
Photograph ID: 39

Photo Location:			
End of works			
Direction:			
Survey Date: 25/08/2022			
Comments: Topsoil bund resintated and metal fence fixed and locked			
Photograph ID: 40

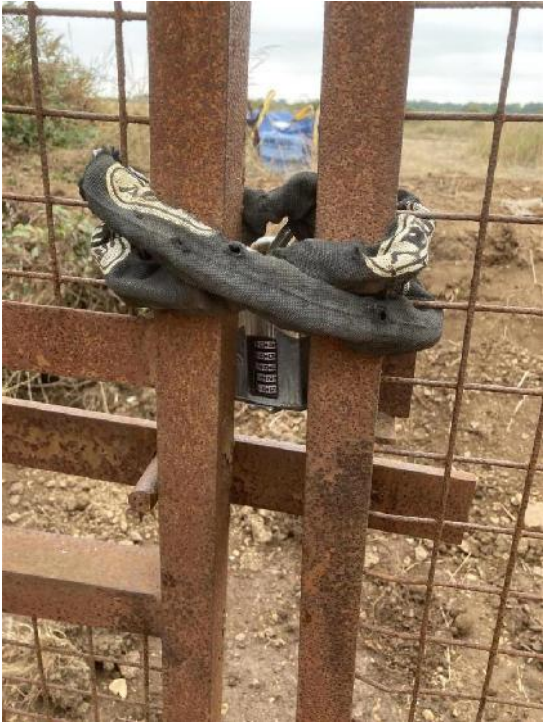
Photo Location:			
End of works			
Direction:			
Survey Date: 25/08/2022			
Comments: Gate chained up and locked
