Re: Proposed extraction of sand and gravel at Hamble Airfield: further response to consultee queries

Stantec undertook the hydrogeological and hydrological impact assessments that supported the planning application and we have been asked to respond on the points raised in relation to hydrology and hydrogeology.

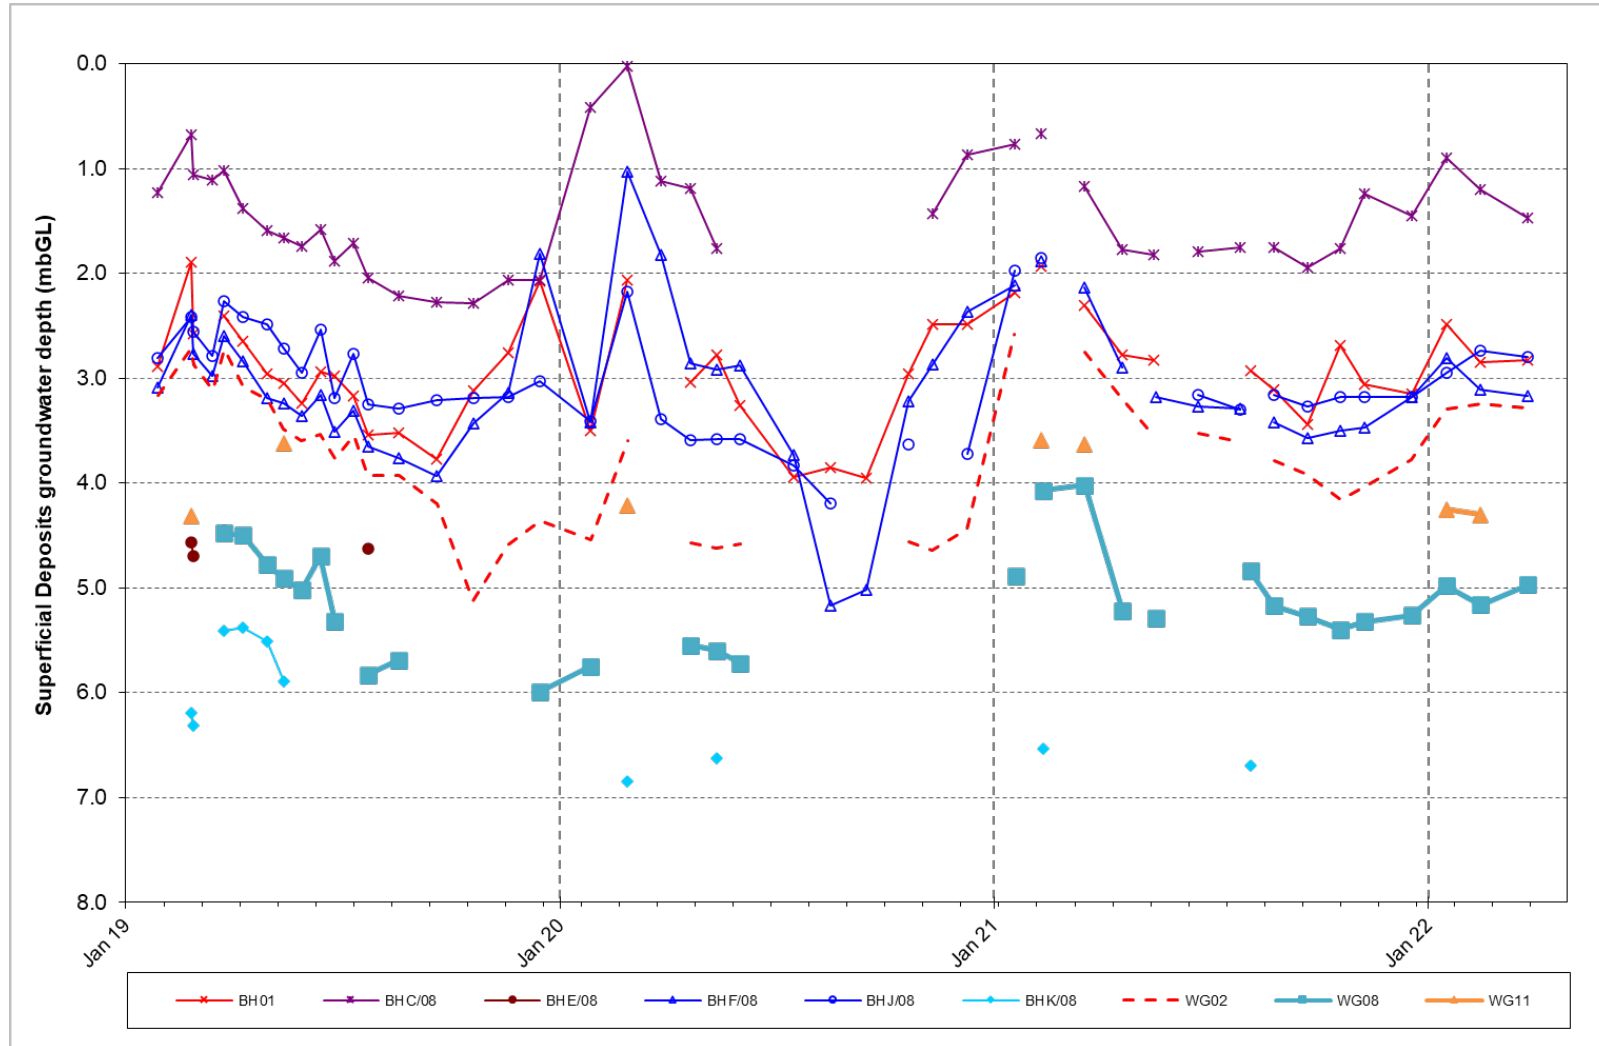
Figure 1 Superficial deposit hydrographs – depth below ground level

The railway line runs along the northern edge of the Site, adjacent to Phase 1, which will be the first Phase to be excavated at the site. Figure 1 shows the depth to groundwater in the superficial deposits at the groundwater monitoring wells at the Site (see Figure 8.14 in Chapter 8 of the Environmental Statement for well locations). BH01, WG02 and BHC/08 monitor groundwater along the northern edge of the Site.

We note that there is little groundwater present within the superficial deposits to the south of Phase 1 of the proposed quarry, particularly on the western and southern sides. The gaps in the hydrographs for the wells to the south of Phase 1 shown on Figure 1 mostly represent occasions when the wells are dry. To illustrate this further, we have enclosed plots showing the dip to water and plumbed base of each of the wells that are monitoring the sand and gravel deposits, which show the limited saturated thickness and periods when wells are dry within the sand and gravel deposit.
